**LITTLE TUNNEL  
STABILITY ASSESSMENT  
CUMBERLAND GAP, TENNESSEE**

**Vaughn & Melton Engineers  
P.O. Box 1425  
Middlesboro, Kentucky 40965**

**April 1995**

**953-3720**

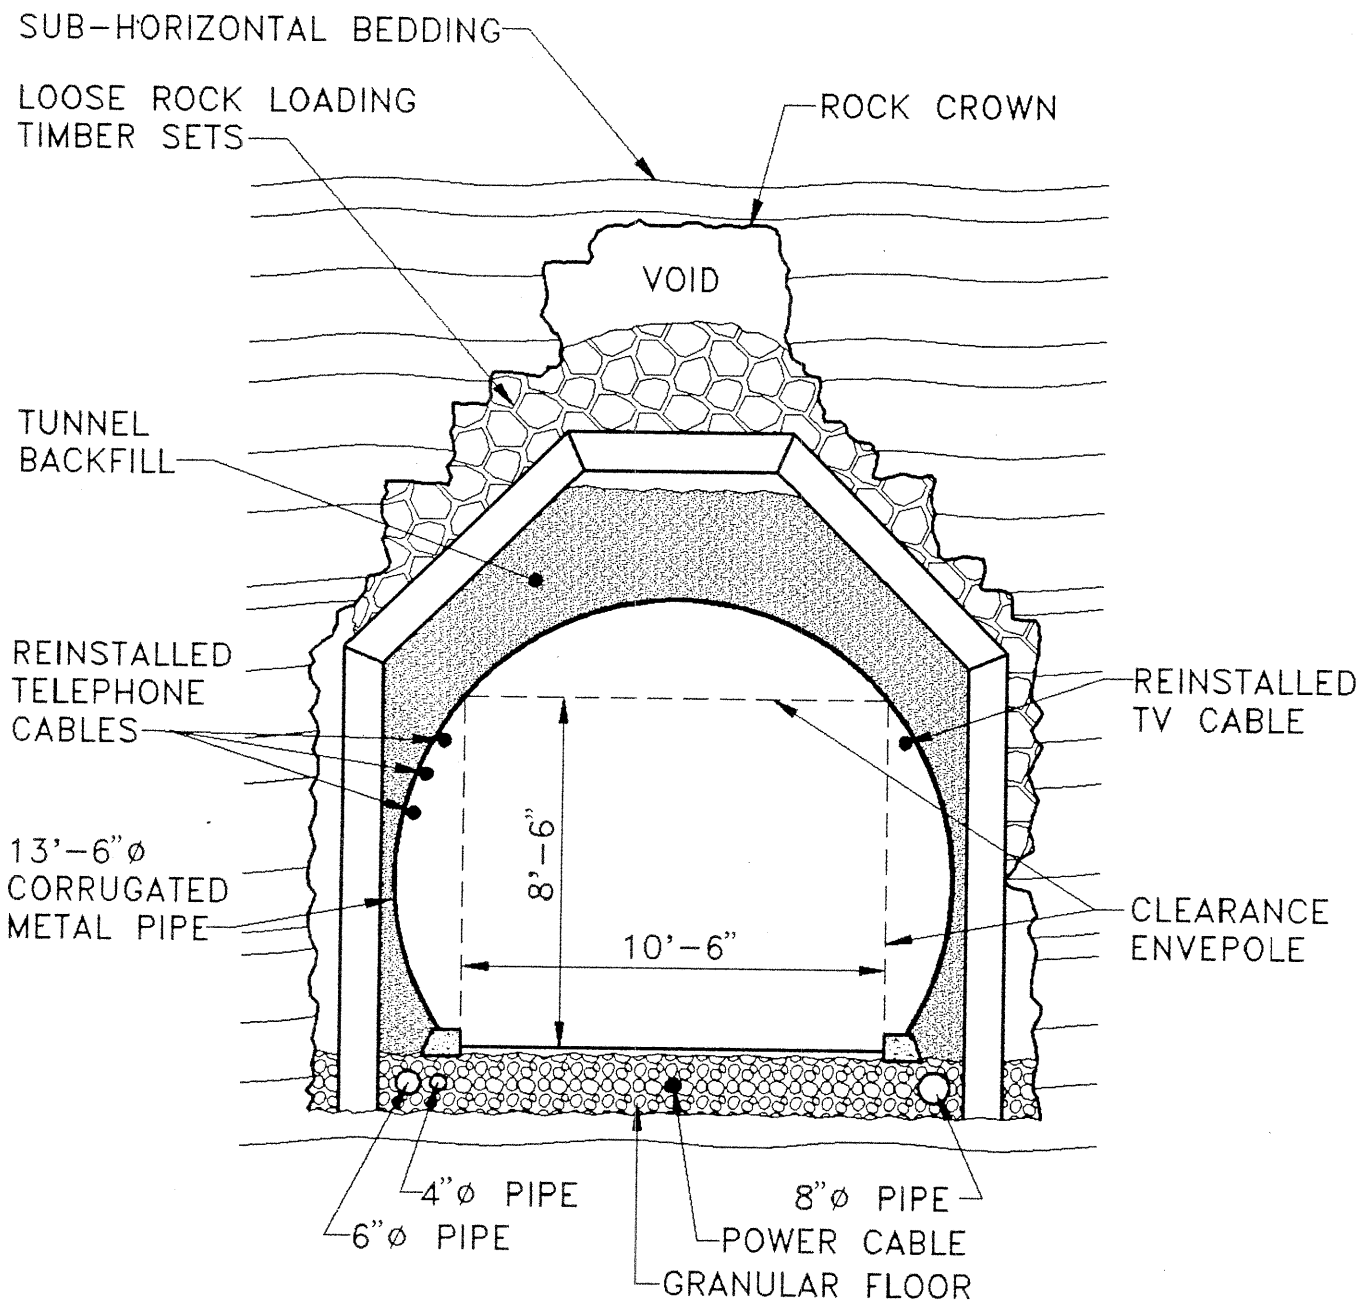
DRAWN	RMS	DATE	2/95	JOB NO.	953-3720
CHECKED		SCALE	NTS	DWG NO.	1
REVIEWED		FILE NO.	953-3720	SUBTITLE	FIGURE NO. 1

The brick lining in the tunnel is in excellent condition and there is no observable deterioration since the 1986 logging. However, the timber sets and wooden lagging in the remainder of the tunnel vary significantly from severely deteriorated to apparently solid and stable. In general, in this timber lined section of the tunnel, pieces of rock have broken loose from the original excavated tunnel section and are lying on the timber sets and lagging, as shown on Figure 1. The horizontal limestone beds have stoped up and appear to have formed a stable rock crown above the timber sets, with a void between the loose rock and the rock crown. The load of loose rock that is sitting on top of the timbers varies considerably. In places, it is severely overstressing the timber sets.

In general, there has been significant deterioration in the condition of the timbers in the tunnel over the nine years since the previous logging. Many of the timbers have rotted significantly and some of the timber sets are distorted from the load of the loose rock resting on top of them.

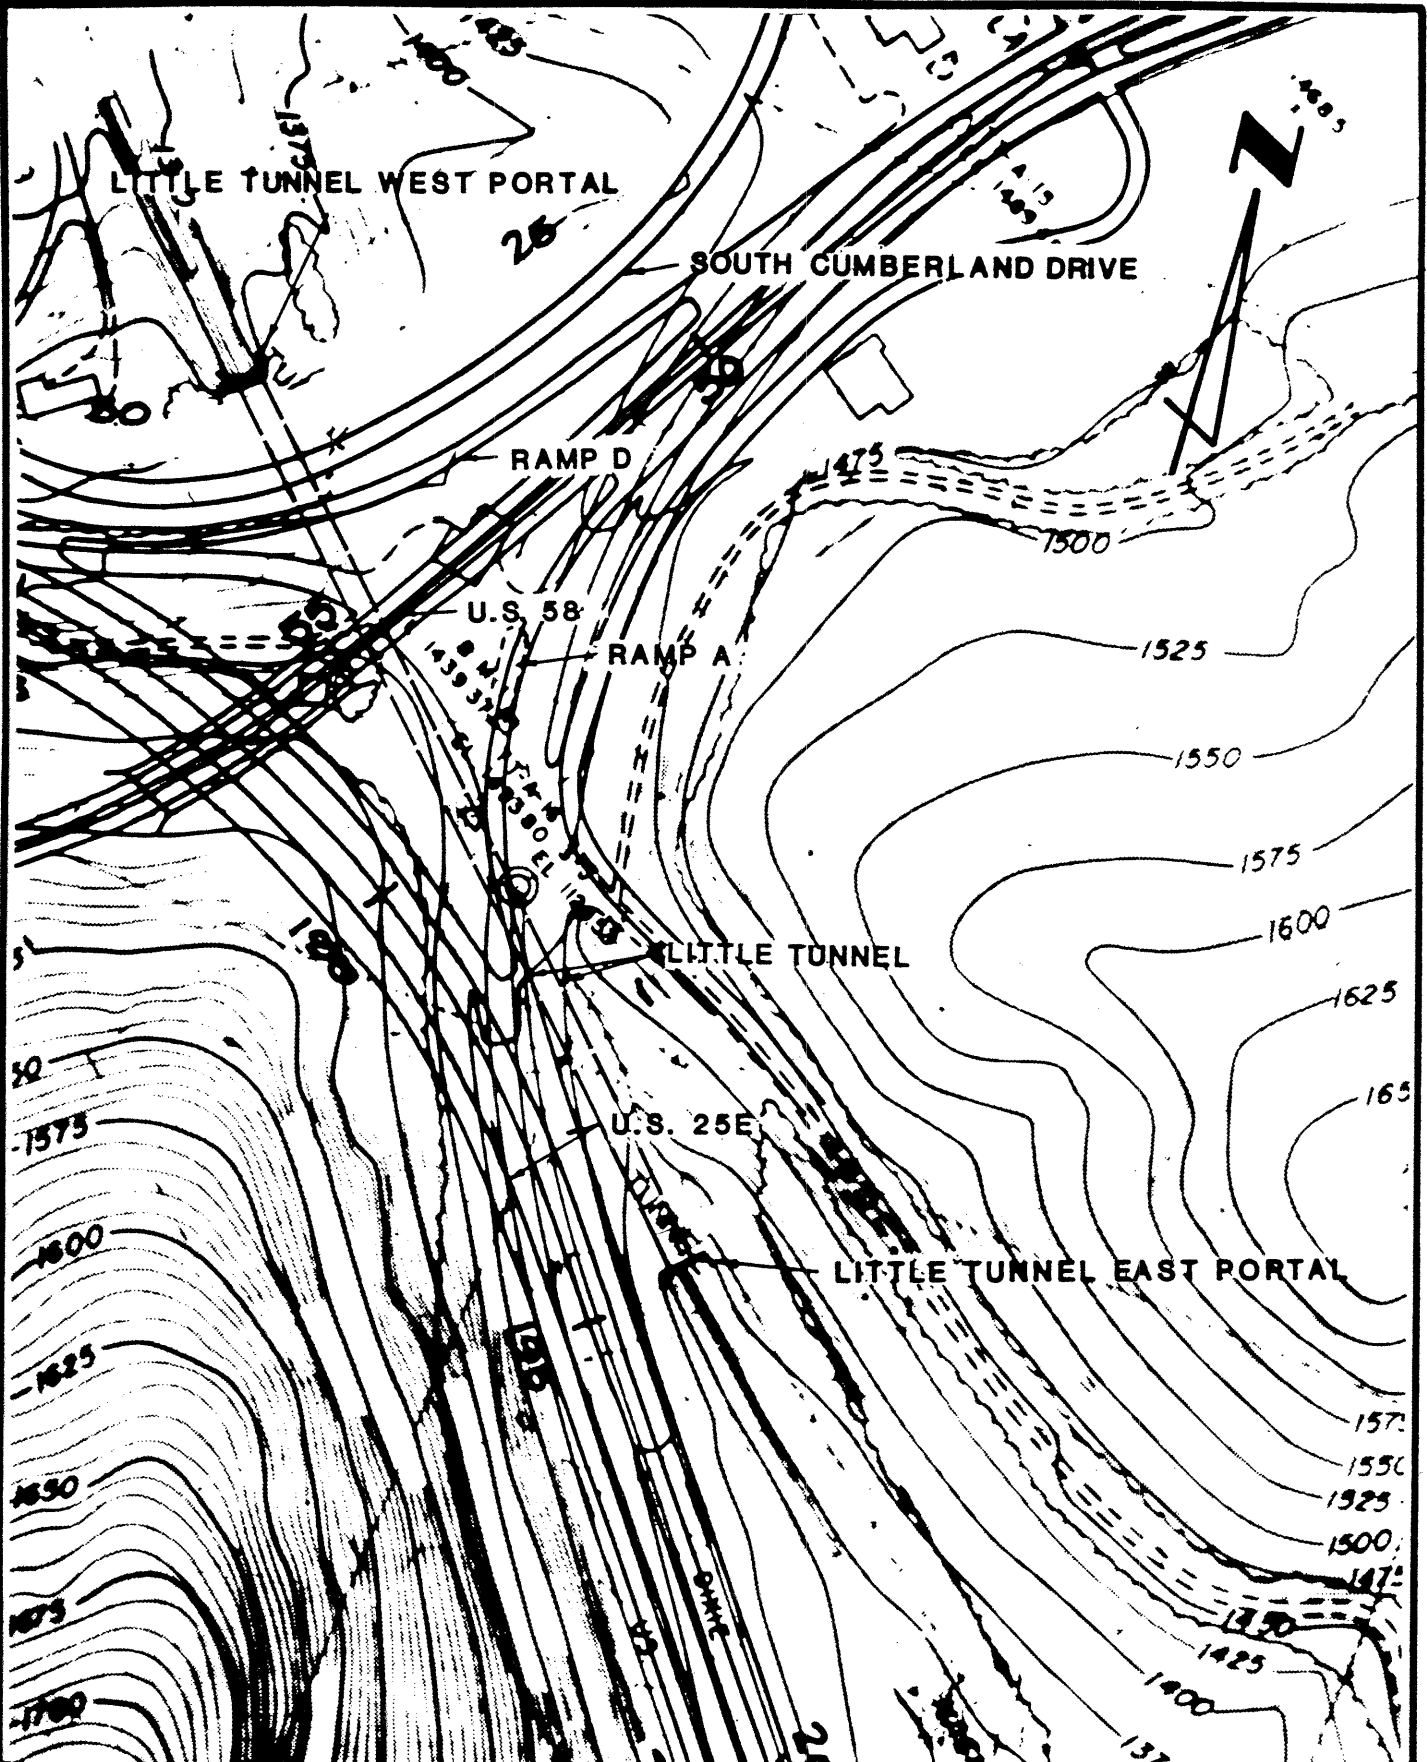
JOB NO. 853-3256	SCALE 1" = 200'	SITE PLAN - LITTLE TUNNEL	
DRAWN JLW	DATE 2-18-86		
CHECKED	DWG. NO.		
Golder Associates		LEE WAN & ASSOCIATES	FIGURE 1

The location of Little Tunnel in reference to the highway relocation work is shown in Figure 1. The present owner of the tunnel is the Seaboard System Railroad, Inc. The line and the tunnel have been essentially abandoned for a number of years and recently Seaboard has applied to officially abandon them. We understand that, upon abandonment by the railroad, the ownership of the tunnel reverts back to
